## Dunedin Cycle Lanes Safety Audit

New Zealand Cycling Conference – Christchurch, September 2001

# Dunedin Cycle Lanes Safety Audit

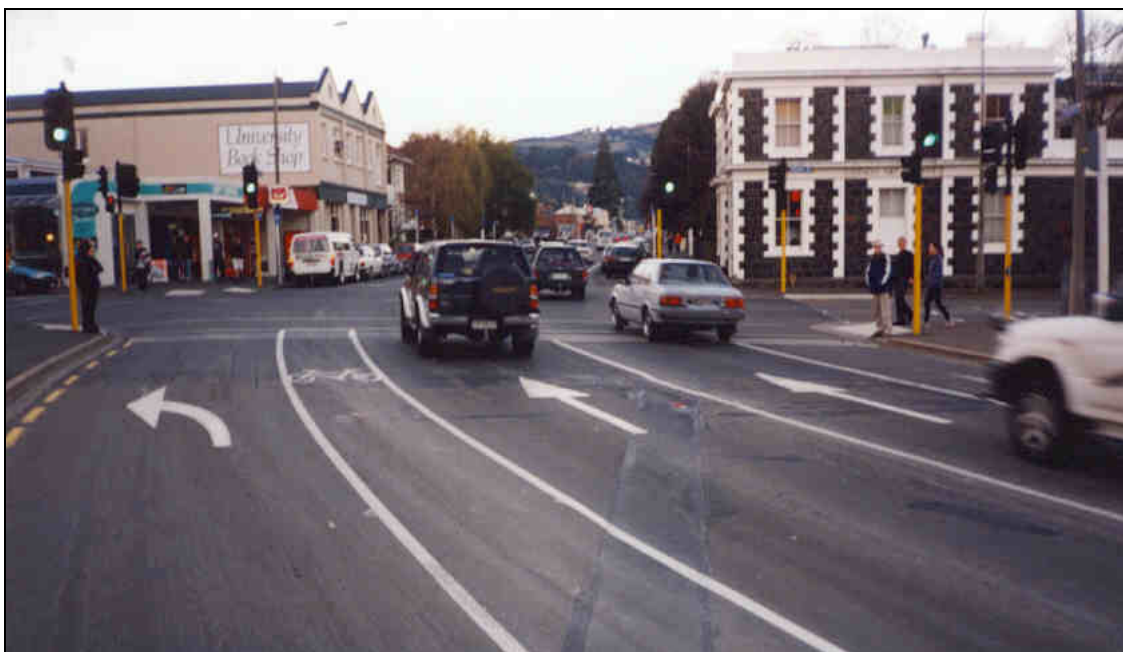
At signal controlled intersections with dedicated left turn lanes, the mid-block parking and clearance widths were sufficient to provide for the left turn lane. The cycle lane itself then slots between the turn lane and the adjacent general traffic lane, as illustrated in Photo 1 below. Cyclists wishing to turn left or right are expected to use the dedicated turn lanes respectively, along with general traffic.

**Photo 1: Typical layout at signalised intersection.**

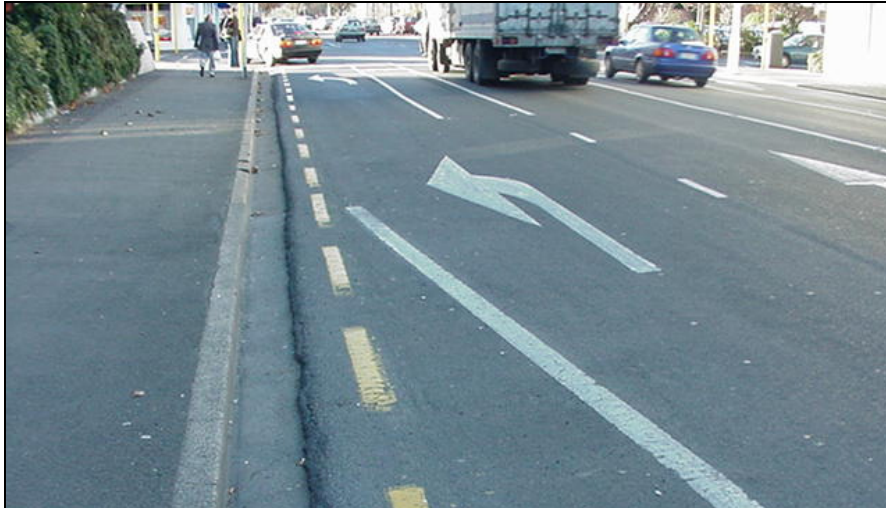
One of the reasons car drivers parked far from the kerb appeared to be the excessive build-up of asphalt at the edge of the road. In some locations, the difference between the elevations of the edge of seal and the lip of the drainage channel exceeded 5 cm, as illustrated in Photo 2. In this case, cyclists inadvertently straying off the seal (or forced off by errant motor vehicles) might fall into the road while trying to return to the roadway.

**Photo 2: Excessive build-up of asphalt presents a potential hazard to cyclists**

Concern was expressed in the audit for the edge of seal condition on New Zealand roads, in that no standards could be found detailing the relationship between the level of the edge of seal and an adjacent concrete channel. In Dunedin (and elsewhere in New Zealand), roads are often resealed with asphalt accumulating to significant depths (often over 5 cm) at the road edge. This can result in unsafe cycling conditions, where cyclists who stray off the asphalt might not be able to return to the roadway. In addition, where parking is authorised, some drivers seem reluctant to park close to the kerb if there is a large drop to the drainage channel. This results in parked cars encroaching into the space needed by cyclists. The audit recommended the creation of national standards for edge of seal/lip of channel transitions.

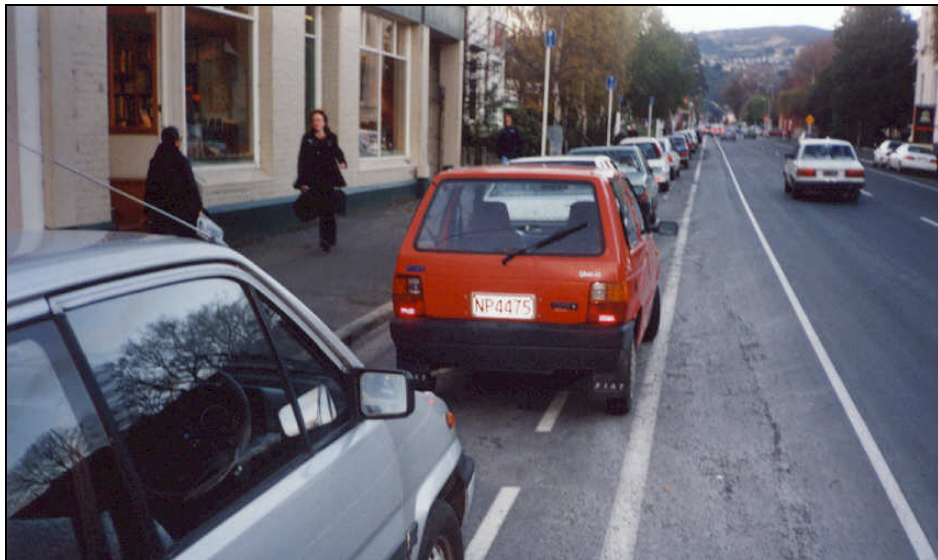
Generally, it was felt that parking needed to be constrained as close to the kerb as possible (about 2.0 m) to encourage more orderly parking. Wider parking stalls tend to result in sloppier parking habits, reducing the amount of usable space for cyclists. This issue is particularly pertinent now from a national perspective as different road controlling authorities grapple with the same issue, and different solutions are being implemented. Opportunities to debate and resolve the issue, such as at this conference, should be used to full advantage.

**Photo 3: Poor parking discipline puts cyclists at risk from opening car doors.**

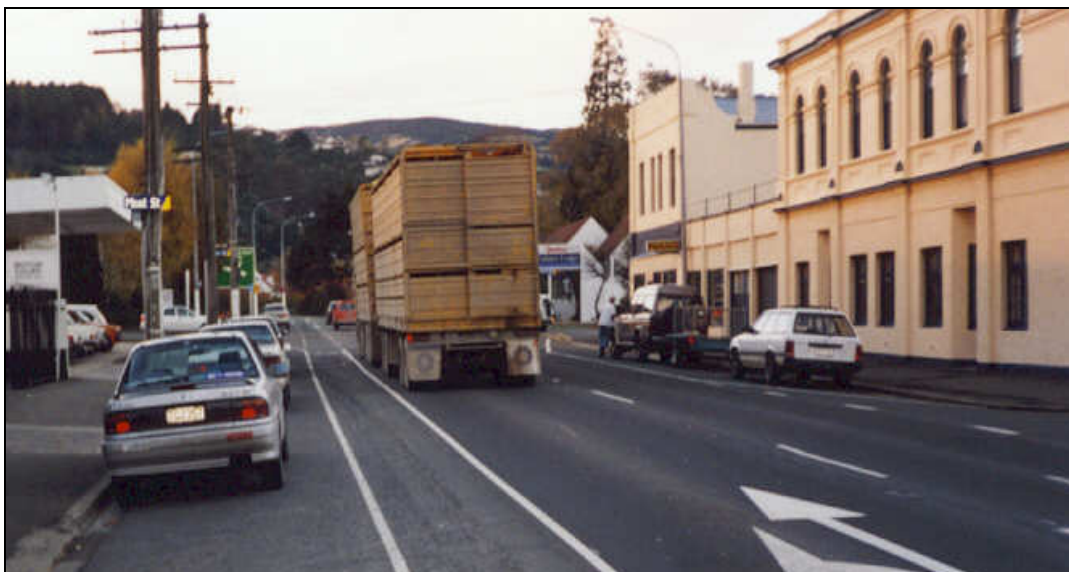
**Photo 4: The left edge line for the cycle lane would be more useful closer to the kerb to constrain parking.**

The use of a left edge line some 2.7 m from the kerb was considered to be superfluous and potentially confusing. Instead, it was recommended that the left edge line for the cycle lanes be removed in favour of parking markings located about 2.0 m from the kerb to encourage car drivers to park close to the kerb. The need for a left edge line for the cycle lane (to define the car door opening envelope, as in Photo 3 below) was considered to be less compelling than the need to simplify the pavement marking design. In some locations, three parallel lines exist in the space of two metres (as in Photo 3). Cyclists routinely cycle alongside parked cars and appreciate the potential of winning the "door prize". In constrained traffic conditions, cyclists tend to cycle as close to the general traffic lane and as far from parked cars as possible. The widening of the space between parked cars and the general traffic lane, combined with the cycle lane's solid edge line on the right, were the design features of greatest merit for cyclists.
