THE CHANGING SIGNAL FACES OF CYCLING

Megan Gregory, MET, BE(Hons), MEngNZ

It's time to give cycle signals a face-lift!

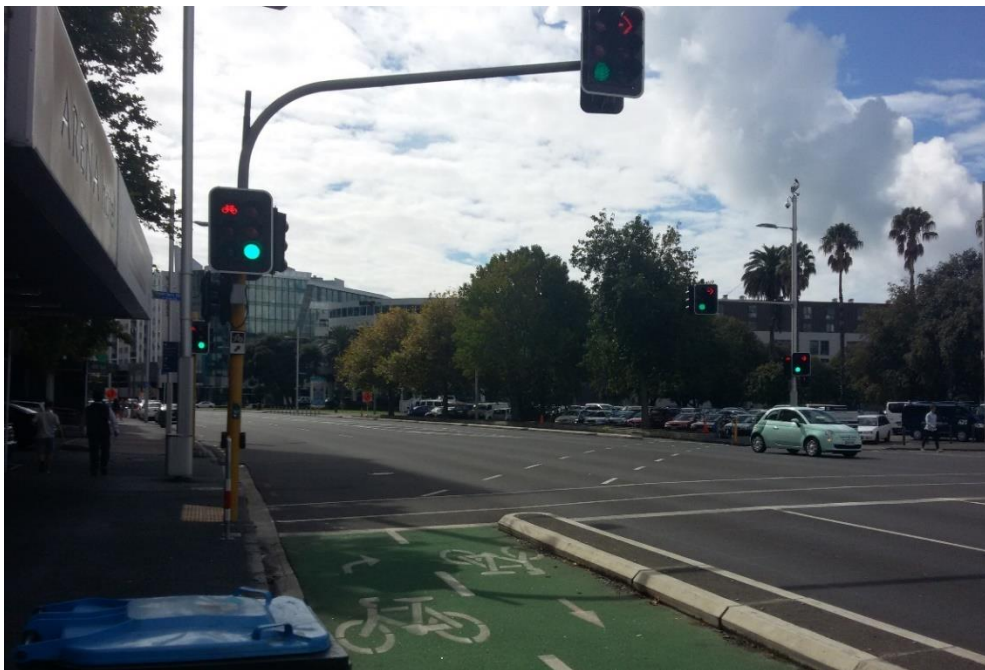
Figure 1: Beach Road diagonal crossing with original signals

The problem is increasingly evident as the complexity of cycle networks increases and separated cycleways are introduced. One example is the diagonal cycle crossing installed at Beach Road / Te Tao Crescent in Auckland in 2014. The cycle signal was green when cyclists could cross the intersection diagonally, and red when the general traffic could go. The problem was that the cycle signals also applied to people wishing to cycle straight ahead, meaning they must be stopped for most of the intersection phase time, including when it would be perfectly safe to continue straight ahead parallel to the adjacent through traffic. Many cyclists wished to travel straight ahead and chose to run a red light rather than accept the unnecessary delay. Before the trial, Auckland Transport had no way of signalling the two cycle movements separately.

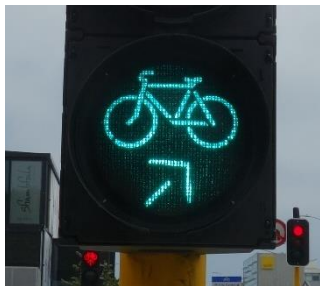
Figure 4: Green diagonal cycle signal, High St / Madras St / St Asaph St

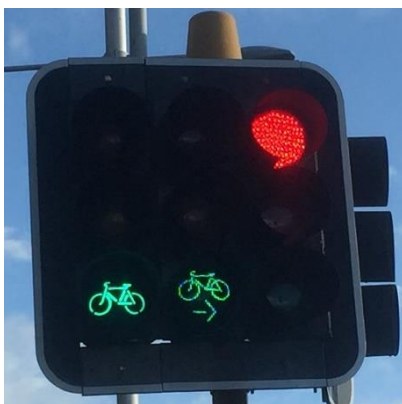
Figure 6: Combined primary signal head, Beach Rd / Te Taou Crs

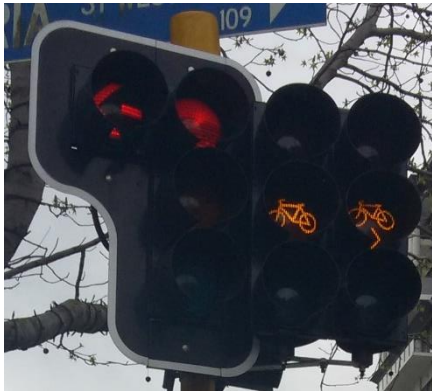
Figure 8: Combined far-side signal head, Nelson St / Victoria St

Another difference between the Auckland and Christchurch sites is the placement of the cycle signals with respect to the general traffic signals and the road layout. In the Christchurch survey, one comment was made that it seems unusual that the cycle signals at High St / Madras St / St Asaph St are in separate groups. Comments regarding the location of the cycle signals were more numerous in the Auckland survey; several people suggested the signals were mounted too high, one noted that the Nelson St / Victoria St (i.e. primary) signals (Figure 8) were preferable to those at Beach Rd / Te Taou Crs (Figure 6) due to being separate from the general traffic signals, but one respondent identified the problem that the far-side signals at Nelson St / Victoria St (Figure 8) do not match the road layout.

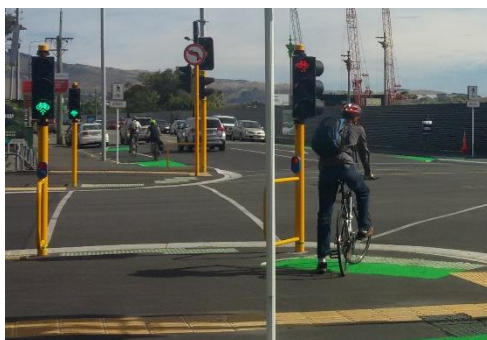
Figure 10: Directional cycle signals on Antigua St north approach to St Asaph St

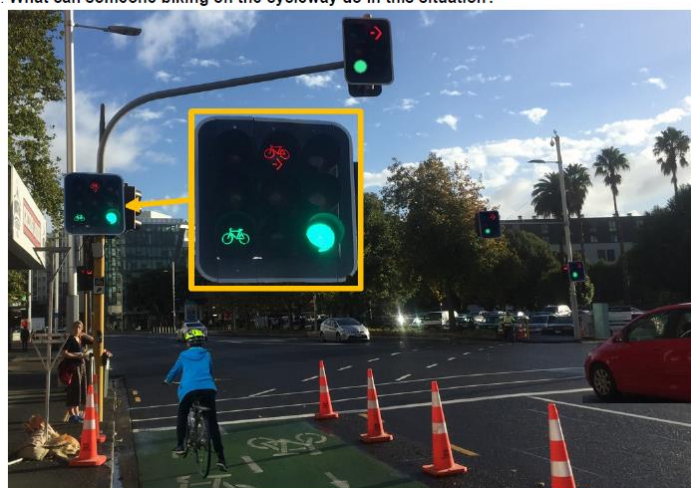
Figure 11: Example of interpretation from Auckland survey

- Interpretation of directional cycle signals (e.g. Auckland example in Figure 11)
 - For different signal displays
 - From the perspectives of riding a bike or driving
- Familiarity with the site since the installation of the directional cycle signals (for different modes of travel)
- General transportation habits
- Demographics – age and gender

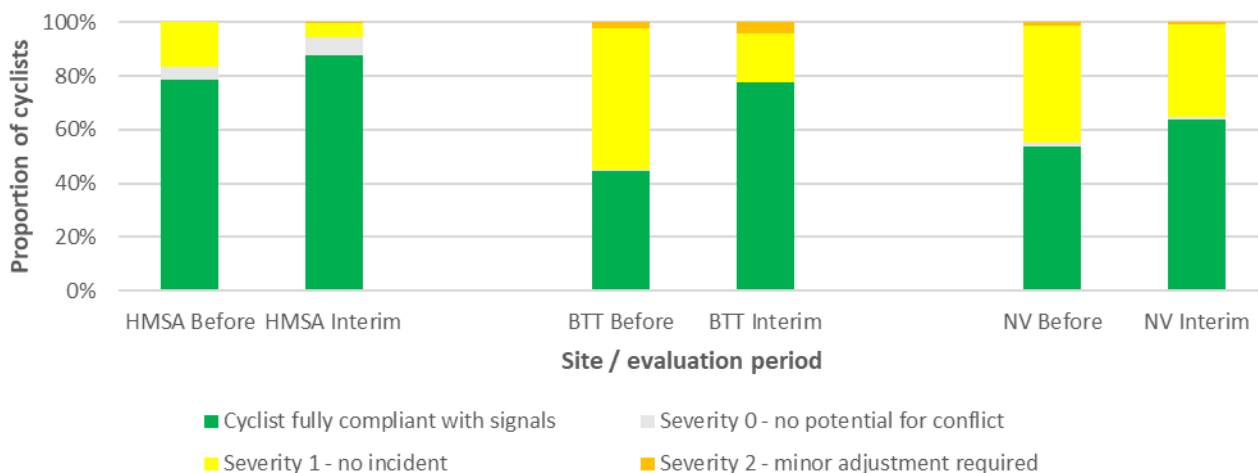
Figure 12 summarises whether cyclists coming from the cycleway approaches studied complied with the relevant traffic signals and the resulting interaction severity of non-compliant manoeuvres, before and after the installation of the directional cycle signals.

Figure 12: Cyclist compliance with traffic signals and interaction severity of non-compliant movements

Note that the category “cyclist fully compliant with signals” has been used to distinguish from interaction severity level 0, as the latter assumes the cyclist did not comply with their traffic signals (i.e. ran a red light) but there was no opposing traffic present and therefore no potential for conflict. Table 3 shows the corresponding chi-squared test results to determine whether the change was significant.

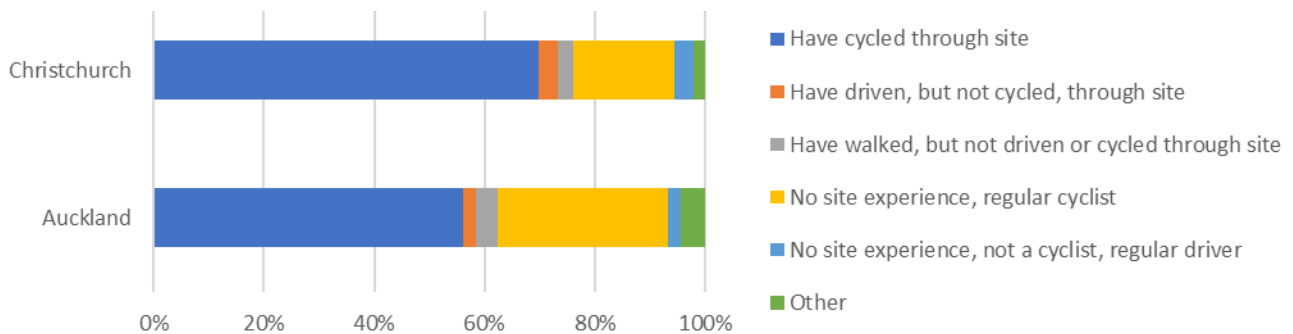
Figure 13: Survey respondents' familiarity with trial sites

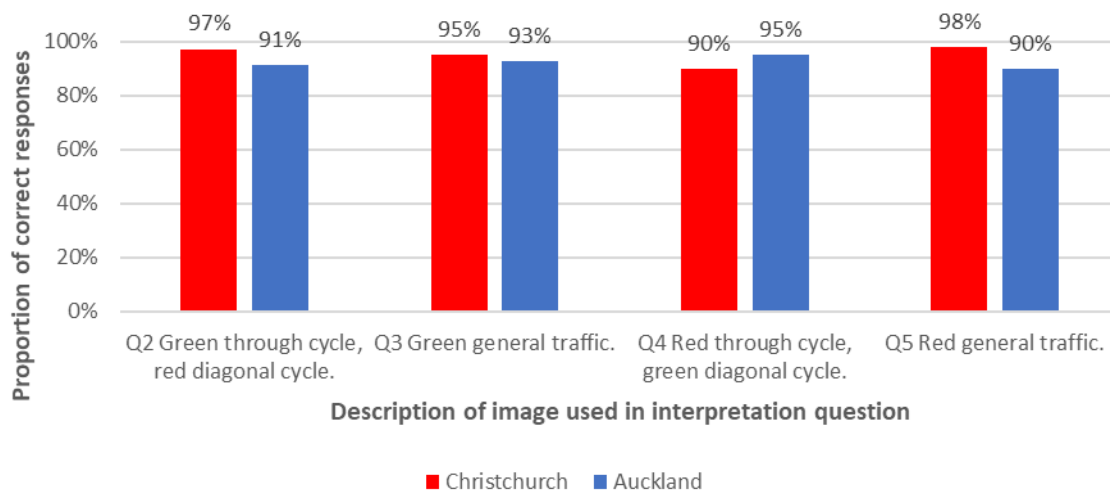
Figure 14 summarises the rate of correct responses to the four questions where users were asked to describe what a cyclist (Q2 and Q4) or a motorist (Q3 and Q5) could do in response to certain signal combinations as displayed in images (Figure 11 shows Q2 from the Auckland survey).

Figure 14: Interpretation of signal combination questions

At least 90% of respondents answered each question correctly – a highly satisfactory result.
